# General Construction Risk Assessment Template

## Boards and Nails Corporation

3/1/19, 2:51 pm

Downtown Berkeley, Berkeley, California

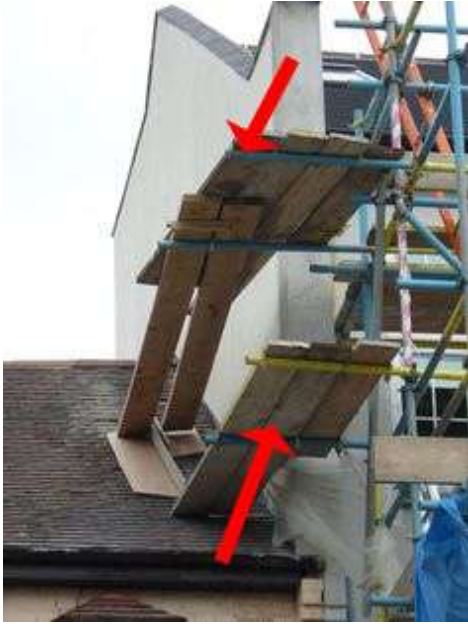
Appendix 1		
Actions: #1		
Brief description	Looked like a makeshift scaffold - but overall dangerous. Planks must be secured and tied to beams and braces.	
Risk rating	High	
2		
Select equipment/process involved	Walkways

**#1. Please remind employees not to makeshift scaffold like this. Use proper scaffolding all the time.**

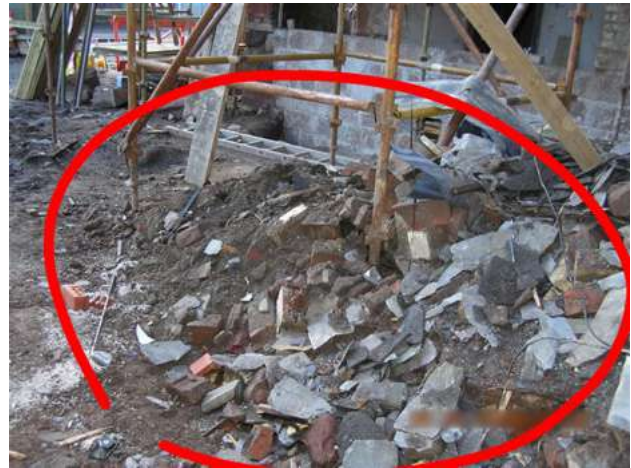
Appendix 2		
Actions: #2		
Brief description	Poor housekeeping - debris, dust/ trash should be cleared off the walkways to avoid obstruction.	
Risk rating	Medium	
3

**#2. This must be clear all the times for everyone's safety. Please look into this as soon as soon as possible.**

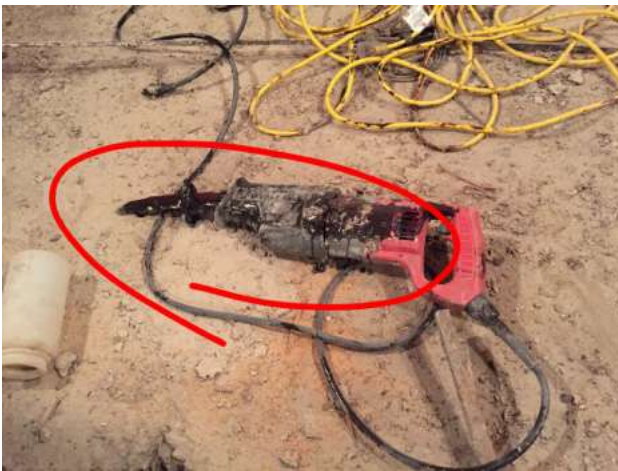
Appendix 3

<p data-bbox="148 465 260 495">Appendix 3</p>		
Actions: #3		
Brief description	Damaged equipment such as this should be kept in a proper storage area and must be replaced as soon as possible to avoid any injuries or further risks.	
Risk rating	High	
4		
Select equipment/process involved	General Work Environment

**#3. Can we replace this please ASAP?**

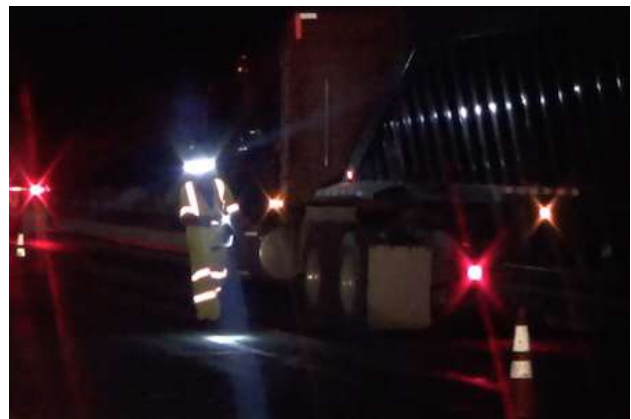
Appendix 4

<p data-bbox="148 1178 260 1207">Appendix 4</p>		
Actions: #4		
Brief description	Inadequate lighting in work areas. Terrible.	
Risk rating	High	
5		
Select equipment/process involved	Hand Tools & Equipment

**#4. Terrible lighting! Can we please do something about this?**

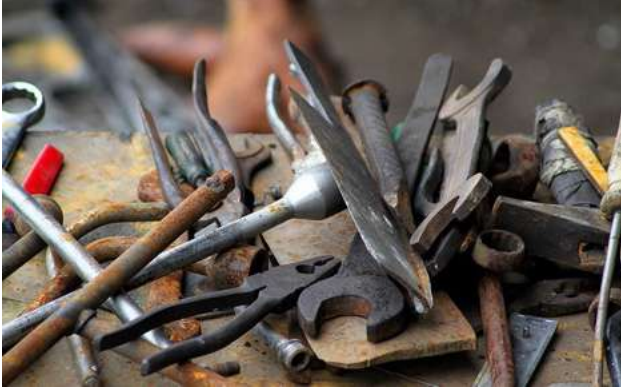
Appendix 5

Question	Response	Details
Brief description	This is just too messy. Tools must be grouped properly. Some are rusty and not healthy for use. This should not be exposed and must be properly stored in a container/ handheld toolbox.	
Risk rating	Medium	
6		
Select equipment/process involved	Electrical

**#5. Please look into this as soon as soon as possible.**

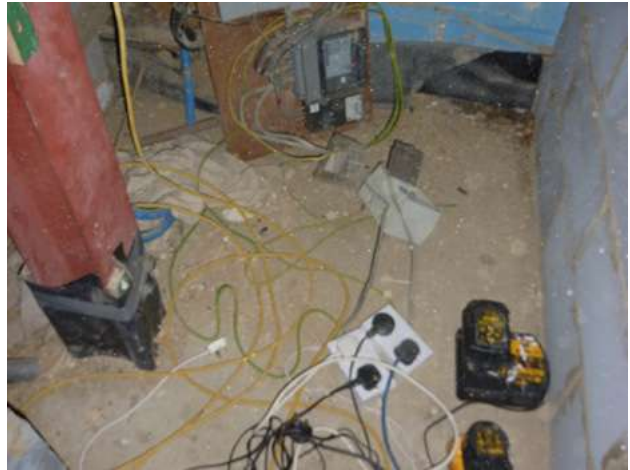
Appendix 6

<p>Appendix 6</p>		
Actions: #6		
Brief description	Messy wiring and is a trip hazard. Please fix this within the day or ASAP	
Risk rating	Medium	
7		
Select equipment/process involved	Personal Protective Equipment	
Actions: #7		
Brief description	One employee on the scaffold located on the left wing refused to wear his goggles as it was too dirty and clouded his vision when working. I understand his reason and we should provide him with goggles in good condition instead ASAP	
Risk rating	High	
<b>Completion</b>		
Additional recommendation	I was told that one crane malfunctioned during shift. Please make sure every equipment is checked properly before and after shift to avoid incidents.

**#6. Please get someone to fix wiring ASAP**
