Floor Inspection Checklist

25 Aug 2021 / Lia Chae-Young

Score	50%	Failed items	0	Actions	3
Name of Homeowner/Building Owner					Irene Joeulgi
Address					490th St, Morris, MN 56267, USA
Contact Details					14154173069
Company Name of Flooring Contractor					Next Level Floors Co.
Registered Address					20th Ave SE, Benson, MN 56215, USA
Contact Details					14154342268
Name of Floor Inspector					Lia Chae-Young
Conducted on					25 Aug 2021 13:02 PST

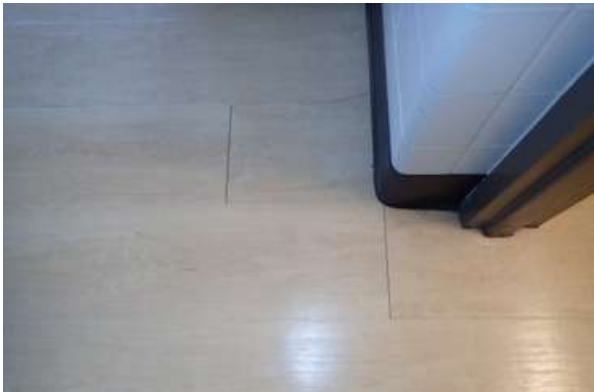
Photo 1

luxury vinyl

multi-function meter revealed the relative humidity and temperature of the room at floor level to be 63.1% at 72°F at the time of this inspection

After taking possession of a new home, there are some maintenance and safety issues that should be addressed immediately. Moreover, plasticizer migration has occurred to the adhesive and the planks.

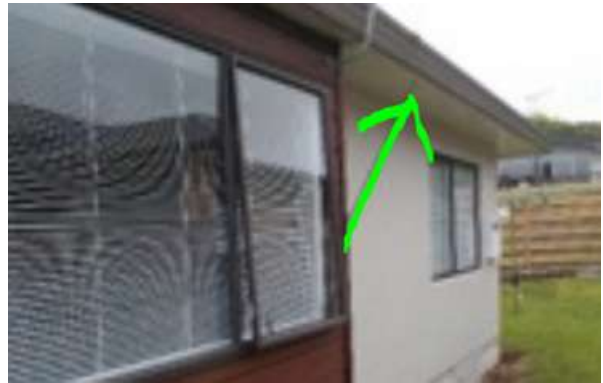
Photo 2

In good condition

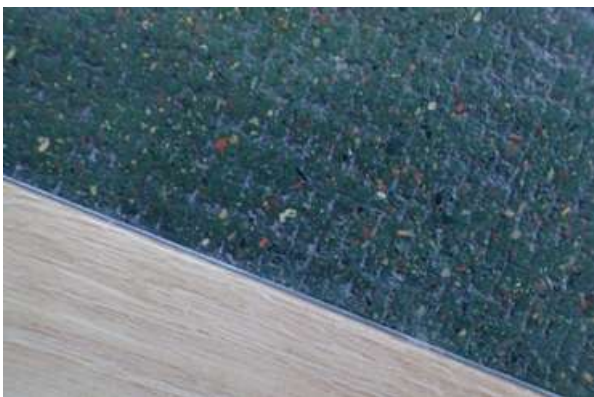
Photo 3

Non-invasive relative moisture meter (0 to 1000) revealed the moisture level on the face of the rubber to be 775

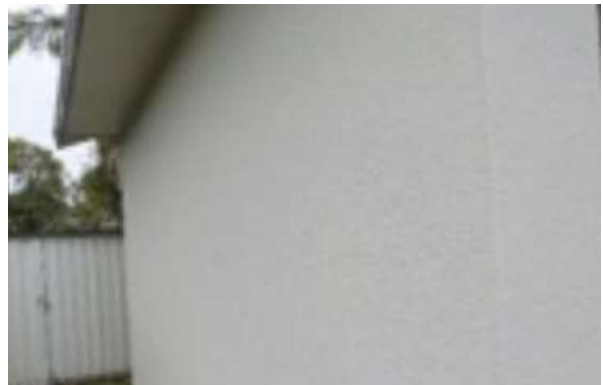
Photo 4

In good condition

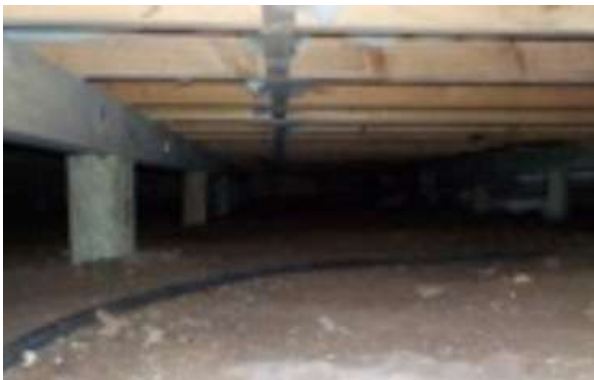
Photo 5

Subfloor is in good condition and is insulated and dry

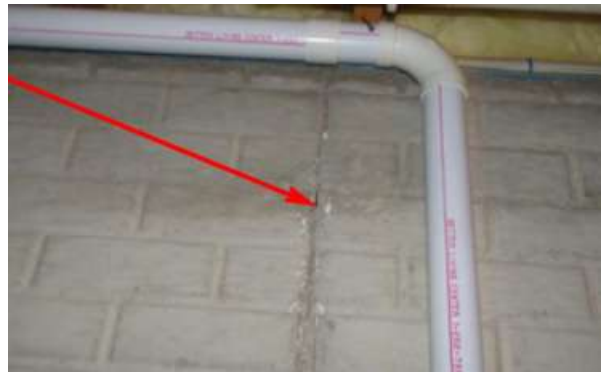
Photo 6

The cracks in the poured concrete foundation show water stains at the cracks that indicates water entry.

Location	left wall upon entrance in basement
Sump Pump	No
HVAC Vents Open to Basement	No
Peeling Paint	Yes

Contact foundation repair company to seal cracks

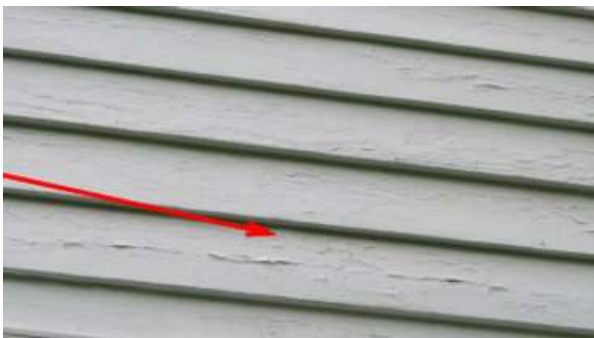
Photo 7

The wood siding should be painted at the rear wall to preserve the basement shed.
