ISO Container Inspection Checklist

1 Feb 2023 / EECU322406 / Expert Exporters Co.

Score	87.67%	Flagged items	9	Actions	3
Site conducted					Unanswered
Shipper					
Expert Exporters Co.					
Country of Origin					United States of America
Container Number					
EECU322406					
Inspected by					Sabrina Diaz
Conducted on					01.02.2023 09:30 PST

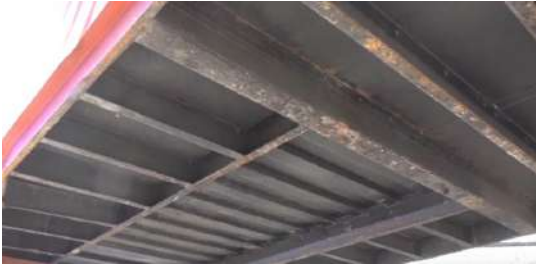
Photo 1

Bottom end rails

Pass

Still in good condition.

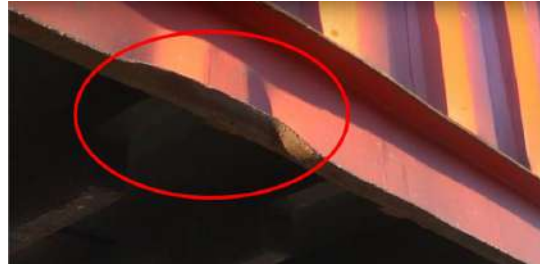
Photo 2

Bottom side rails

Fail

Monitor minor damage

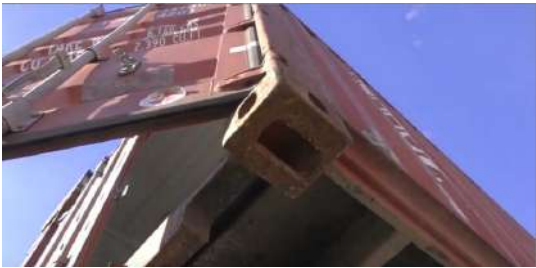
Photo 3

Door sill

Pass

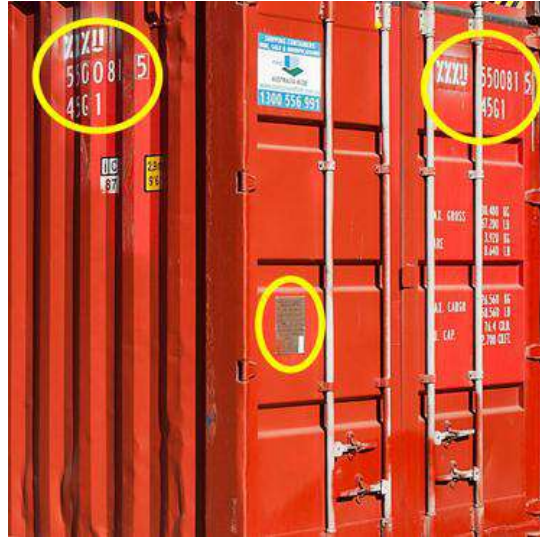
Photo 4

Clearly visible ISO marks and CSC plate

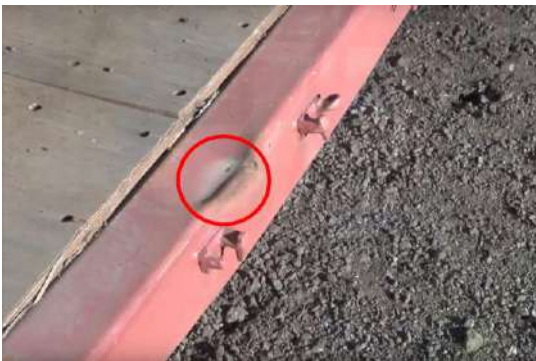
Photo 5

Door fittings

Fail

Monitor minor damage

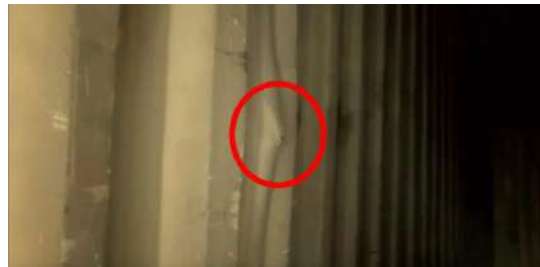
Photo 6

Vertical plate

Fail

Repair left side interior panel

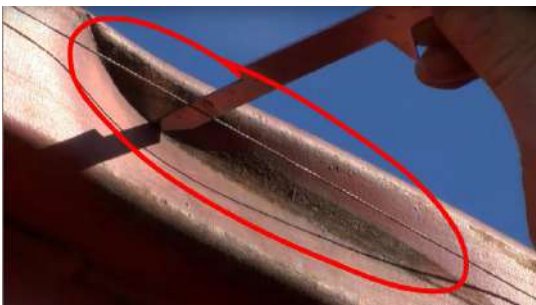
Photo 7

Top side rail

Fail

Monitor minor damage

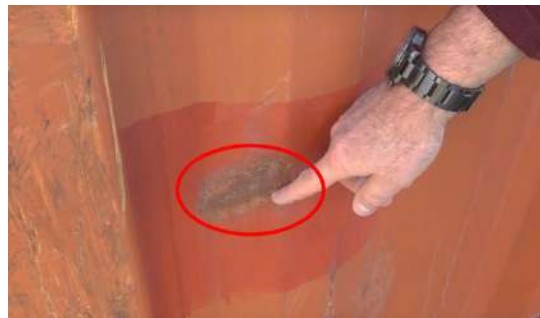
Photo 8

Panel

Fail

Contain small area of corrosion before it spreads

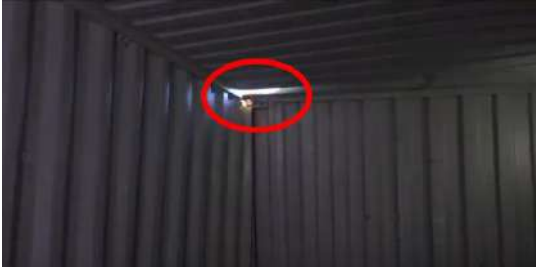
Photo 9

Light leak

Fail

Cover roof hole near front wall

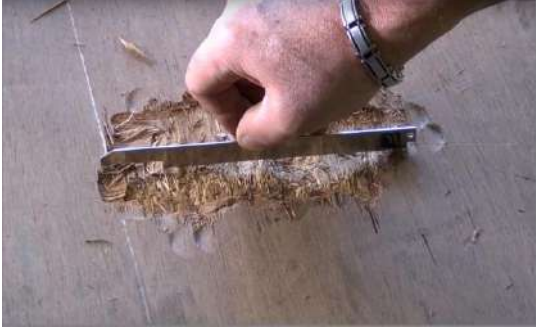
Photo 11

Flooring

Fail

Patch this up, make sure no nails are protruding

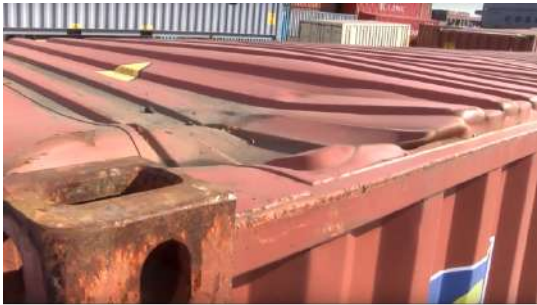
Photo 12

Roof panel

Fail

This is the root cause for roof hole near the front wall. Repair this as well.
