Home Inspection Checklist

Score	96.12%	Flagged items	4	Actions	0
Property Address	4003 Paloma Cir, Austin, TX 78734, USA				
Conducted on	10.05.2023 08:08 PST				
Prepared by	Adam Alexander				
Prepared for	Dianna Stevens

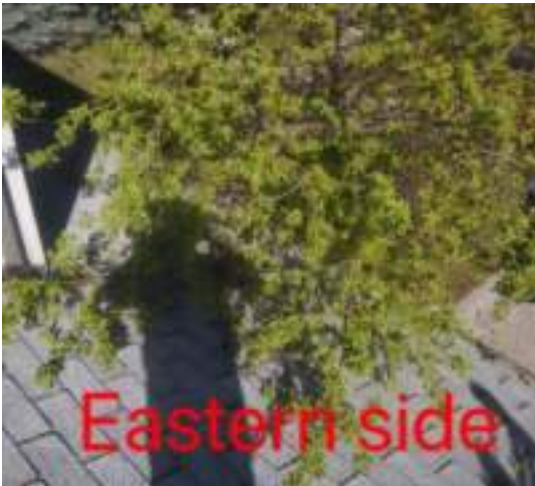
Photo 1

Tree on the eastern side of the house is overhanging the roof.

This house appears to be well-maintained by the previous owner. The only concerns found were on the roof, where there are overhanging branches and appears to be some curling, and on the back of the house, where there is a cat painted on the white wall and some other stains.

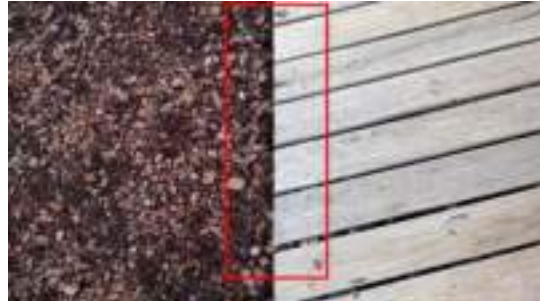
Photo 2

Clearance not adequate. No wood to earth direct contact but almost touching.

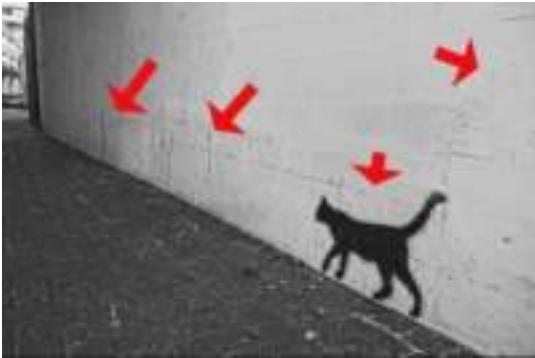
Photo 3

At the back of the house is this painting of a cat and the noticeable shoe print apart from the stains on the white wall.

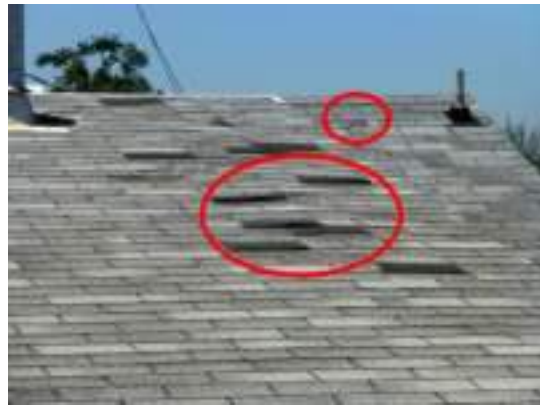
Photo 4

South side roof show signs of curling and damage.
