Site Investigation Report Template

West coast project / 4 Mar 2019 / Erick Brent

Site Investigation Report

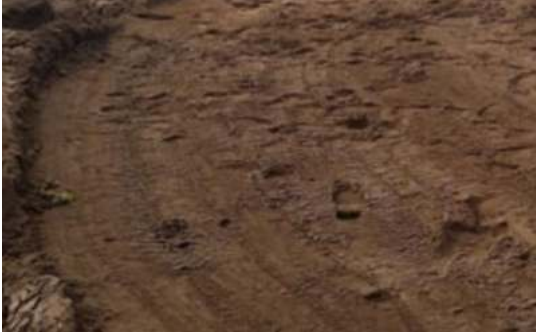
Test Hole No.

1

Texture

Loam

Sand Sizes

Fine

Photo 1

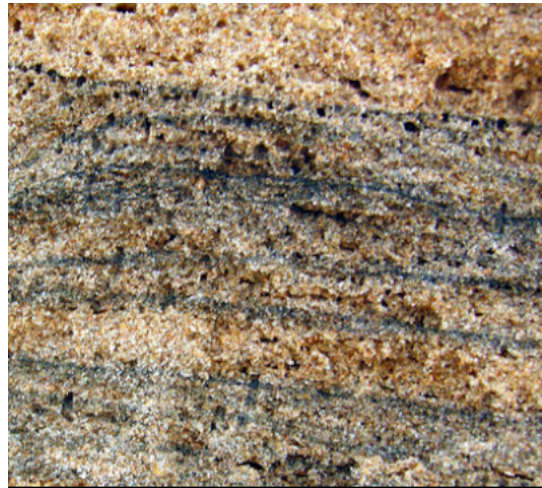
Shape	Granular
Rock Fragments	
Rock Fragments	Irregular
Type of Rock	Sandstone

Photo 2	
Terms of Rock	Stratified
Mottles	
Quantity	Common
Size	Medium
Contrast	Distinct
Boundary	
Distinctness	Gradual
Topography	Irregular
Consistency	
Dry	Slightly Hard
Moist	Friable
