Building Inspection Checklist

Score	93.75%	Flagged items	3	Actions	5
Building ID number					52868B
Building unit					Hostel Unit
Building location					R34Q+5H Millican, OR, USA (43.8053771, -120.9110169)
Conducted on					24 Mar 2022 13:35 PST
Prepared by					Mikkel Galante

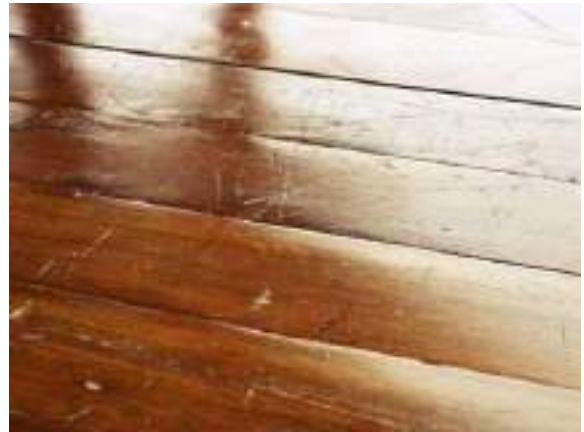
Photo 2

The quality of the wooden floor in the living room needs improvement, as there were many scratches on the floor.

The scratches and dents on the living room floor requires fixing.
